CHEMICAL MANUFACTURING FACILITY CONTAMINATION

Case Study

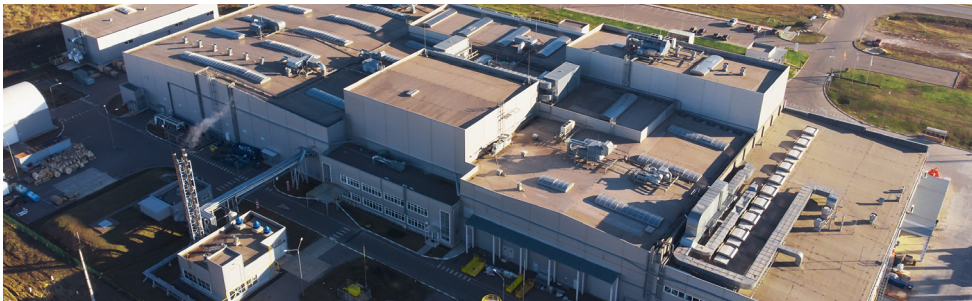
At a chemical manufacturing facility, an employee attempted to redistribute 2,000 pounds of a powdered chemical into four 500-pound containers. The hopper used was not properly cleaned and therefore, the chemicals reacted with each other causing a fire and chemical cloud to engulf the facility. While the main damage of the fire was isolated to one area, the fire released a corrosive gas, which began to cause corrosion of varying degrees throughout the entire production and packaging floor. A large amount of steel began to rust and/or oxidize. Additionally, the electronics had a fine layer of soot in most cabinets.

As most of the equipment was custom, equipment restoration was the more cost- and time-effective solution. AREPA was able to restore all of the equipment that was deemed restorable.
