# HONEY PRODUCTION CENTRIFUGE FIRE

## Case Study

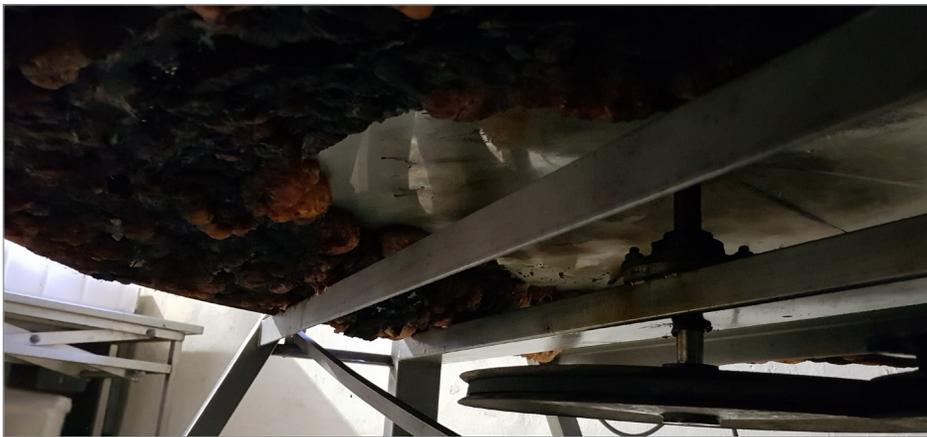
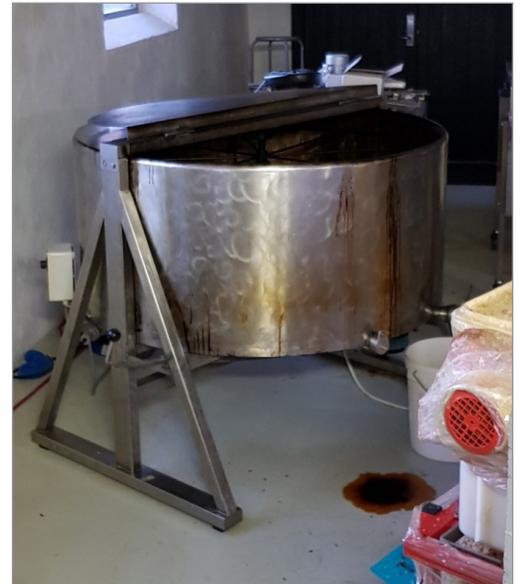
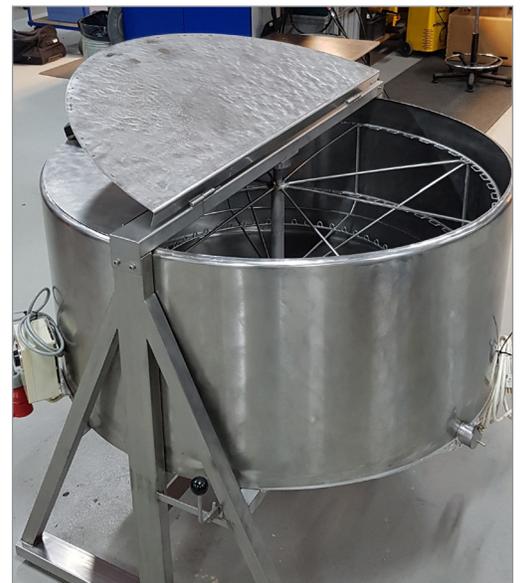
In Mid Jutland, Denmark, a honey production facility experienced a loss when a centrifuge caught fire. As the operator entered the room, the electricity was cut off and the room was filled with smoke that covered the whole area with a sticky soot. The inside carousel of the centrifuge was completely stuck and the bottom side of the tank, the heating element, thermostat and its isolation were completely burned.

AREPA specialists had to remove carbon sucrose residue by hammer and chisel, chemicals and grinding. The heating treads and thermostat had to be approached

in the same fashion. After the contamination was removed, leakage was revealed in the stainless-steel welding between the walls of the container and the bottom of the machine. It was then determined that leaking honey intruded the heat treads and most likely was the cause of the fire.

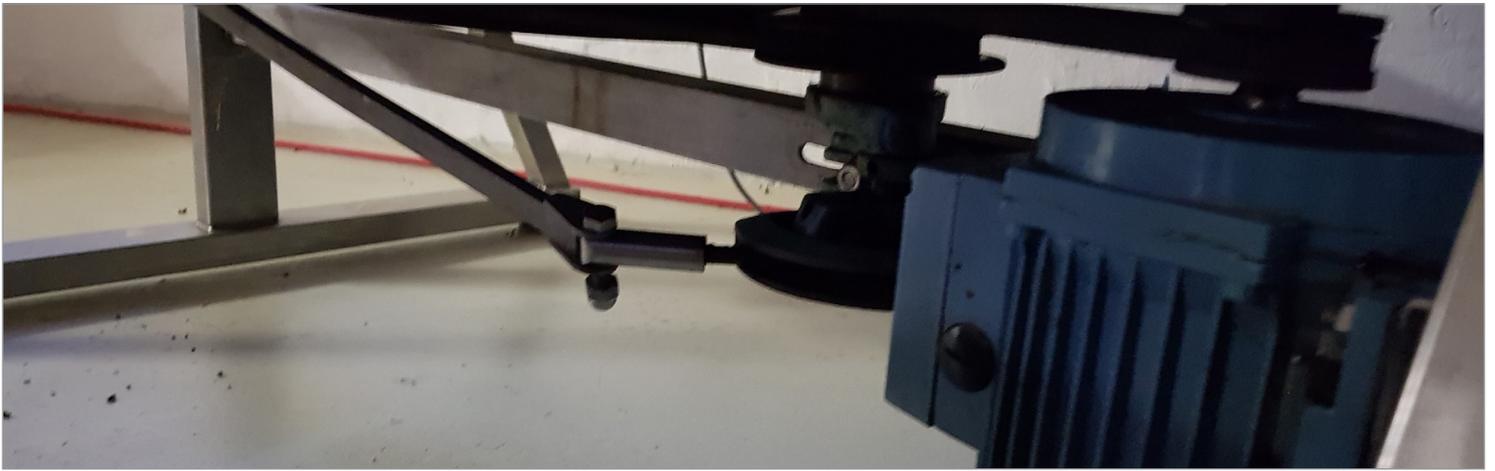
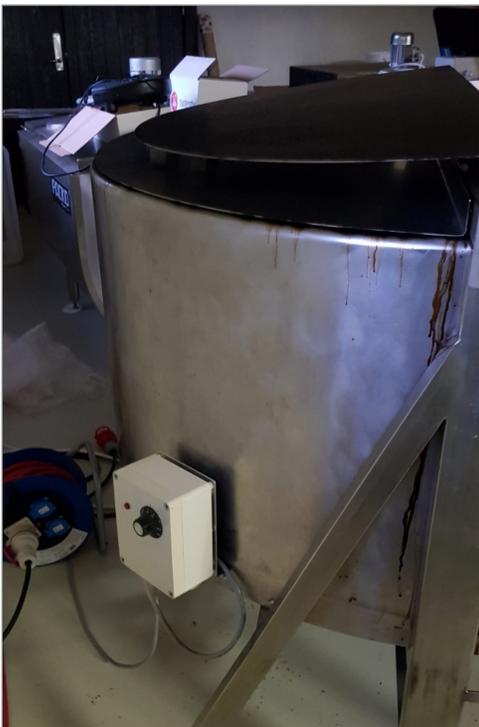
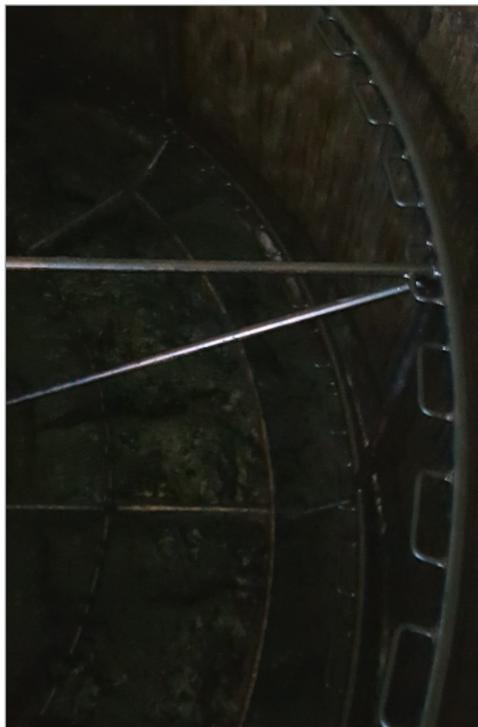
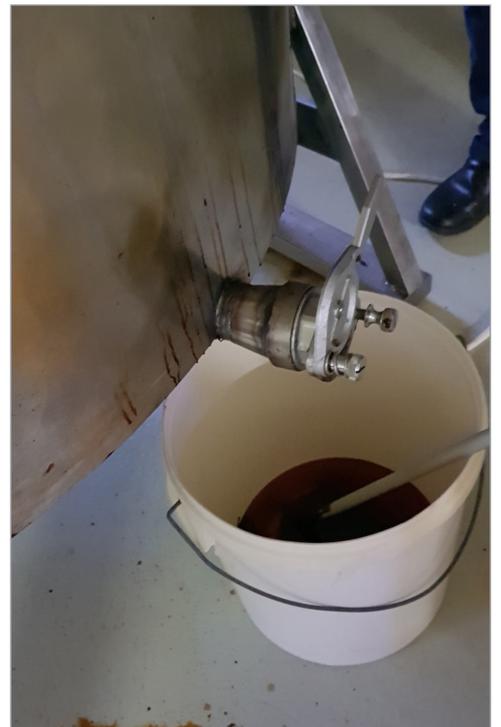
Apart from restoring the engine, drive, controller and fixtures, specialists supplied the machine with new heating treads, thermostat and heat resistant insulation. This was all completed at approximately 50 percent of the price a new piece of equipment and the restoration was completed within four weeks, as opposed to a six to eight month lead time for a new centrifuge.
