# NORWEGIAN POWER CONTAINER STRUCK BY LIGHTNING

## Case Study

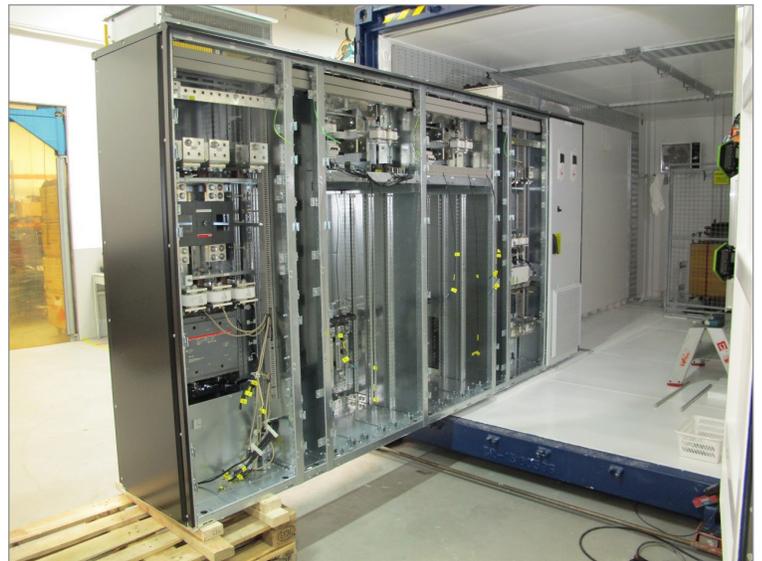
▲ Reassembly of electrical switchboards and container

The switch gears were emptied, converter modules and breakers disassembled completely, and all surfaces were thoroughly cleaned. The unit was returned back to the producer to install new components for the burned/thermal damaged components.

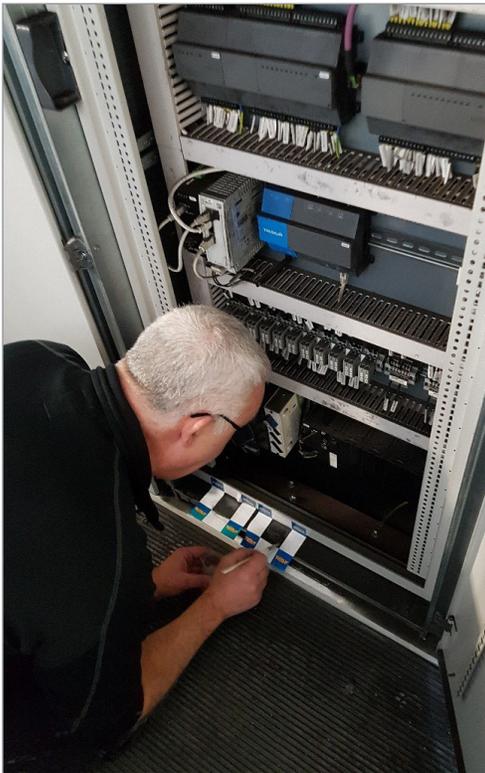
▲ AREPA expert performing scientific analysis to determine the risk of corrosion

During the restoration efforts, AREPA specialists determined that the cables in the installation were halon-free however, AREPA tested  $5-22 \mu\text{gCl}/\text{cm}^2$  that were produced in PVC. All components and panels, except for very heavy coil, were dismantled out of the container, wall coverage flooring was removed and everything was washed down. All surfaces were painted to complete the overall cosmetic look and neutralize any remaining odors.

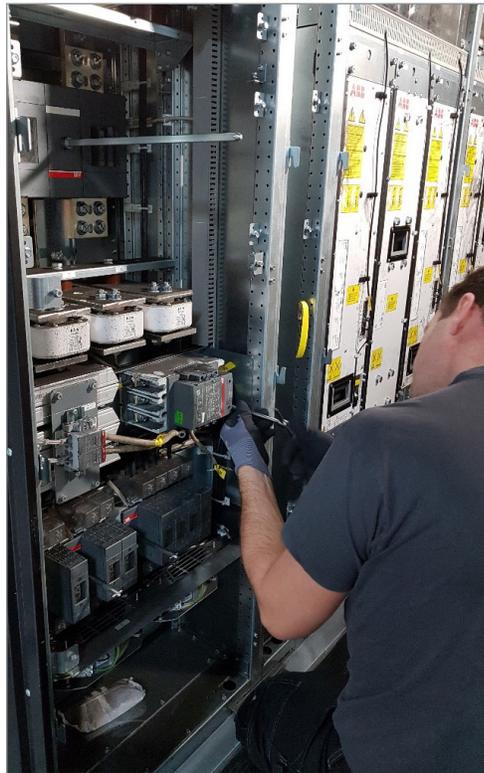
▲ The container and switchboards being disassembled

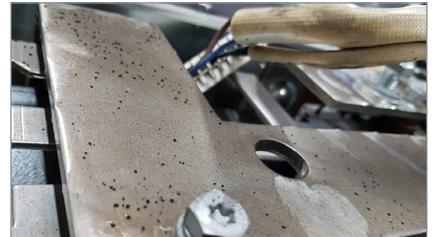
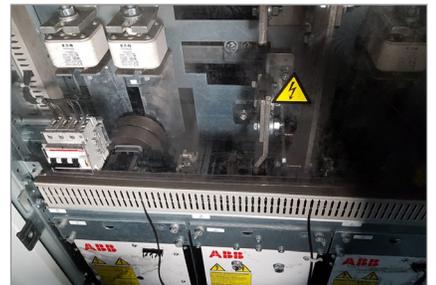
During idle connection based in Stavanger, Norway, this unit was struck by lightning. The producer was alerted about smoke and electrical failure and upon arrival, opened a smoke-filled container. Everything within the container was contaminated and bad thermal damage hit the upper-left corner of three to four switch panels containing lots of cable and cable trays as well as the components in the top of the installations, the smoke detector, and other armatures. As units were built halon-free, there was no concern regarding corrosive ions. When the loss adjuster arrived on site, he noticed indications of corrosion forming on the galvanized surfaces.

▲ Photos show contamination on the equipment
