SOUTH CAROLINA MANUFACTURING PLANT FIRE

Case Study

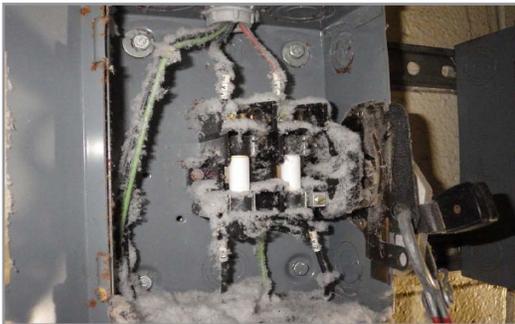
▲ Square D disconnect switch before decontamination

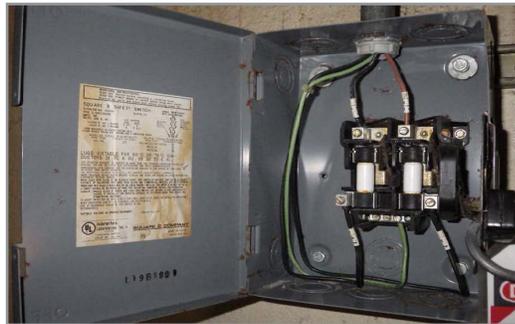
▲ Square D disconnect switch after decontamination

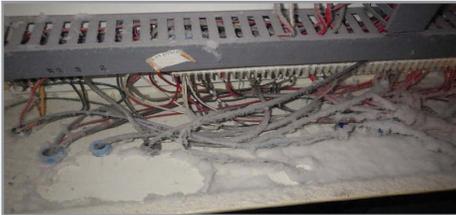
▲ Control panel before decontamination

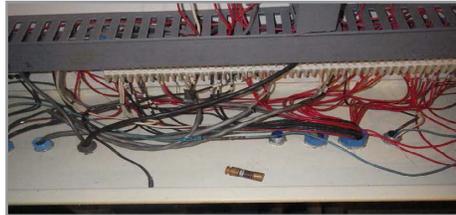
▲ Control panel after decontamination

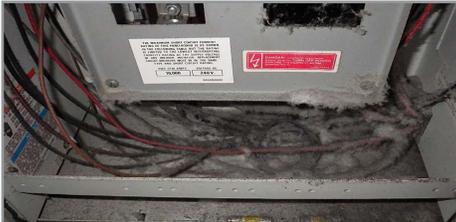
▲ Motor control center (MCC) circuit breaker panel before decontamination

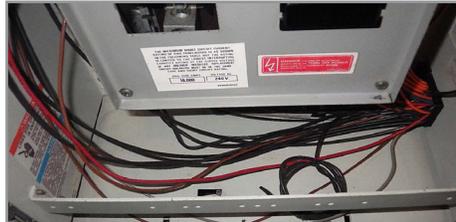
▲ Motor control center (MCC) circuit breaker panel after decontamination

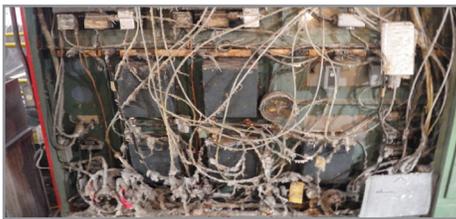
▲ Backside of line R-4 operator's station before decontamination

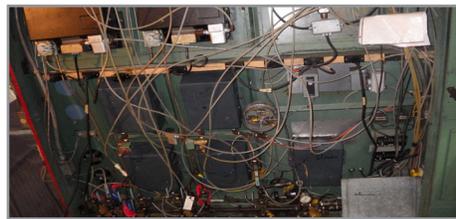
▲ Backside of line R-4 operator's station after decontamination

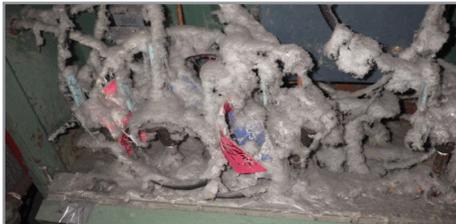
▲ Backside of line R-4 operator's station before decontamination

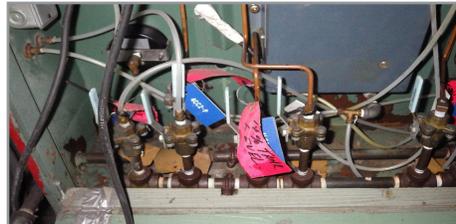
▲ Backside of line R-4 operator's station after decontamination

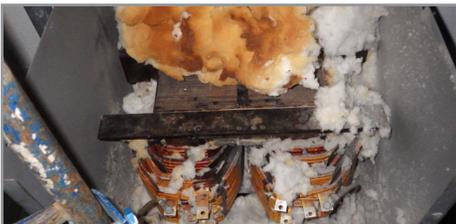
During the decontamination process, AREPA discovered a live transformer that was slowly burning operational debris (cotton) trapped inside the unit. AREPA's discovery prevented another fire. AREPA completed the decontamination within the 14-day timeframe, which allowed the client to resume production in a fraction of the time that replacement would have taken.

▲ Transformer with the burnt cotton before decontamination

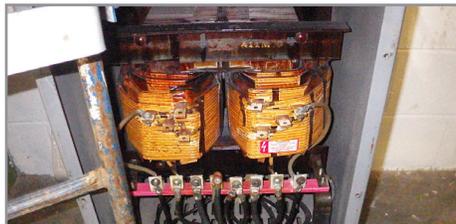
▲ Transformer with the burnt cotton after decontamination

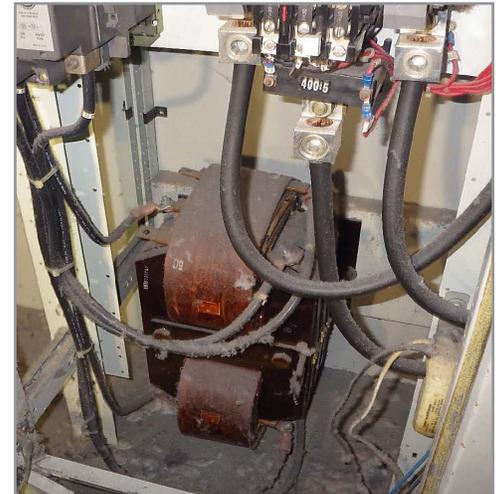
▲ Motor control center (MCC) transformer before decontamination

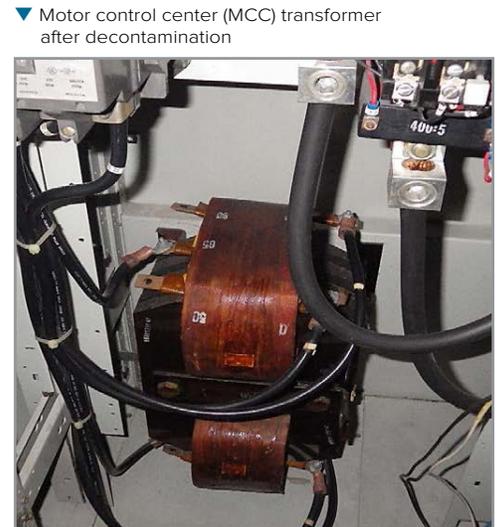
▼ Motor control center (MCC) transformer after decontamination
