AREPA

UNIVERSITY PLANETARIUM STRUCK BY TORNADO

Case Study

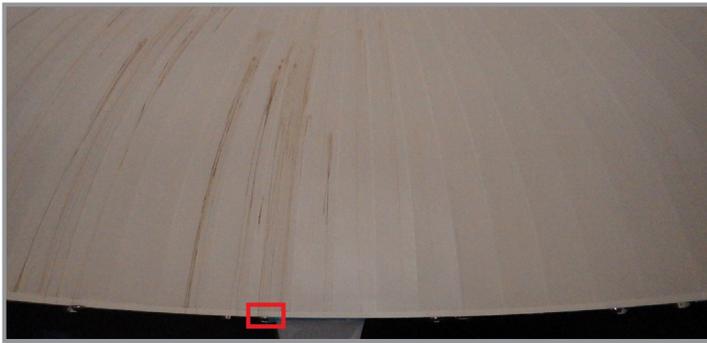
▲ Dome before decontamination

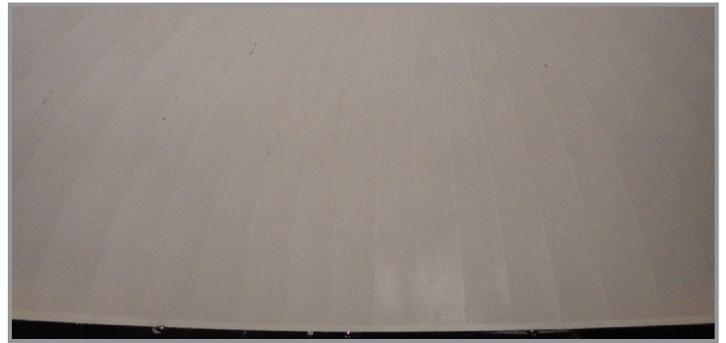
▲ Dome after decontamination

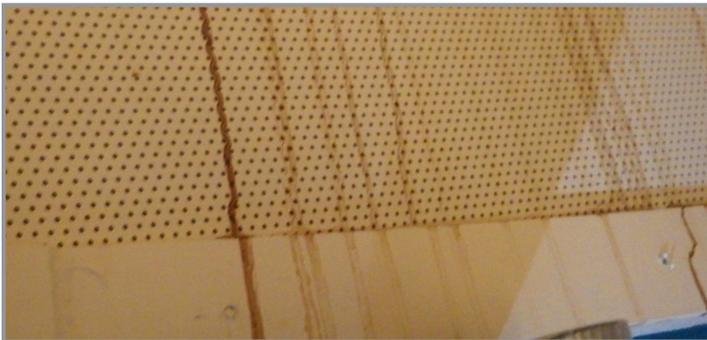
▲ Dome before decontamination

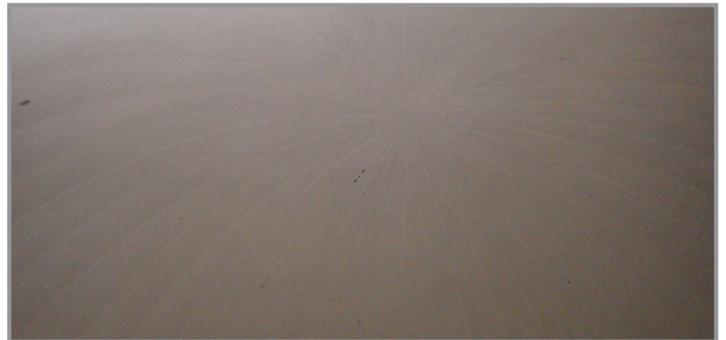
▲ Dome after decontamination

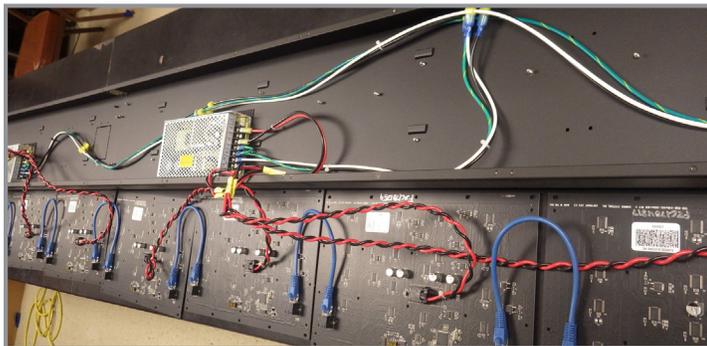
▲ Ticker LED panel opened up for inspection and decontamination. Some water spotting identified and removed.

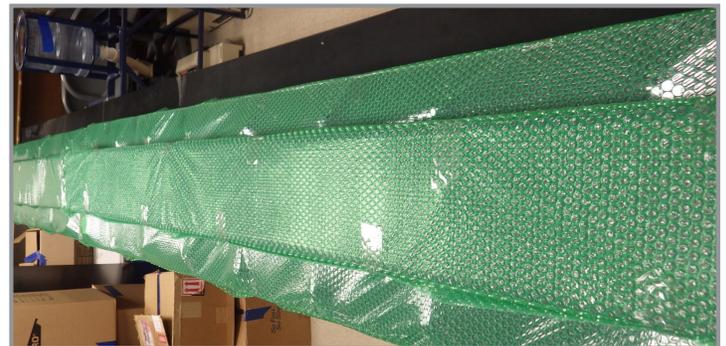
▲ Photo of completed LED ticker bars individually wrapped in protective bubble wrap and stored off the floor on a benchtop. It is important that these are handled with care when moving and avoid stacking anything.
