PUT TO THE CORROSION TEST

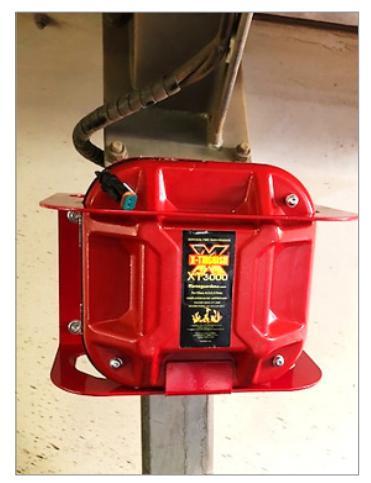
Flame Guard USA X-Tinguish® XT-3000 installed in a turbine
